## ROMAR TRANSPORTATION SYSTEMS CSM Site Summary

Oregon DEQ ECSI #: 2437

9333 N. Time Oil Road

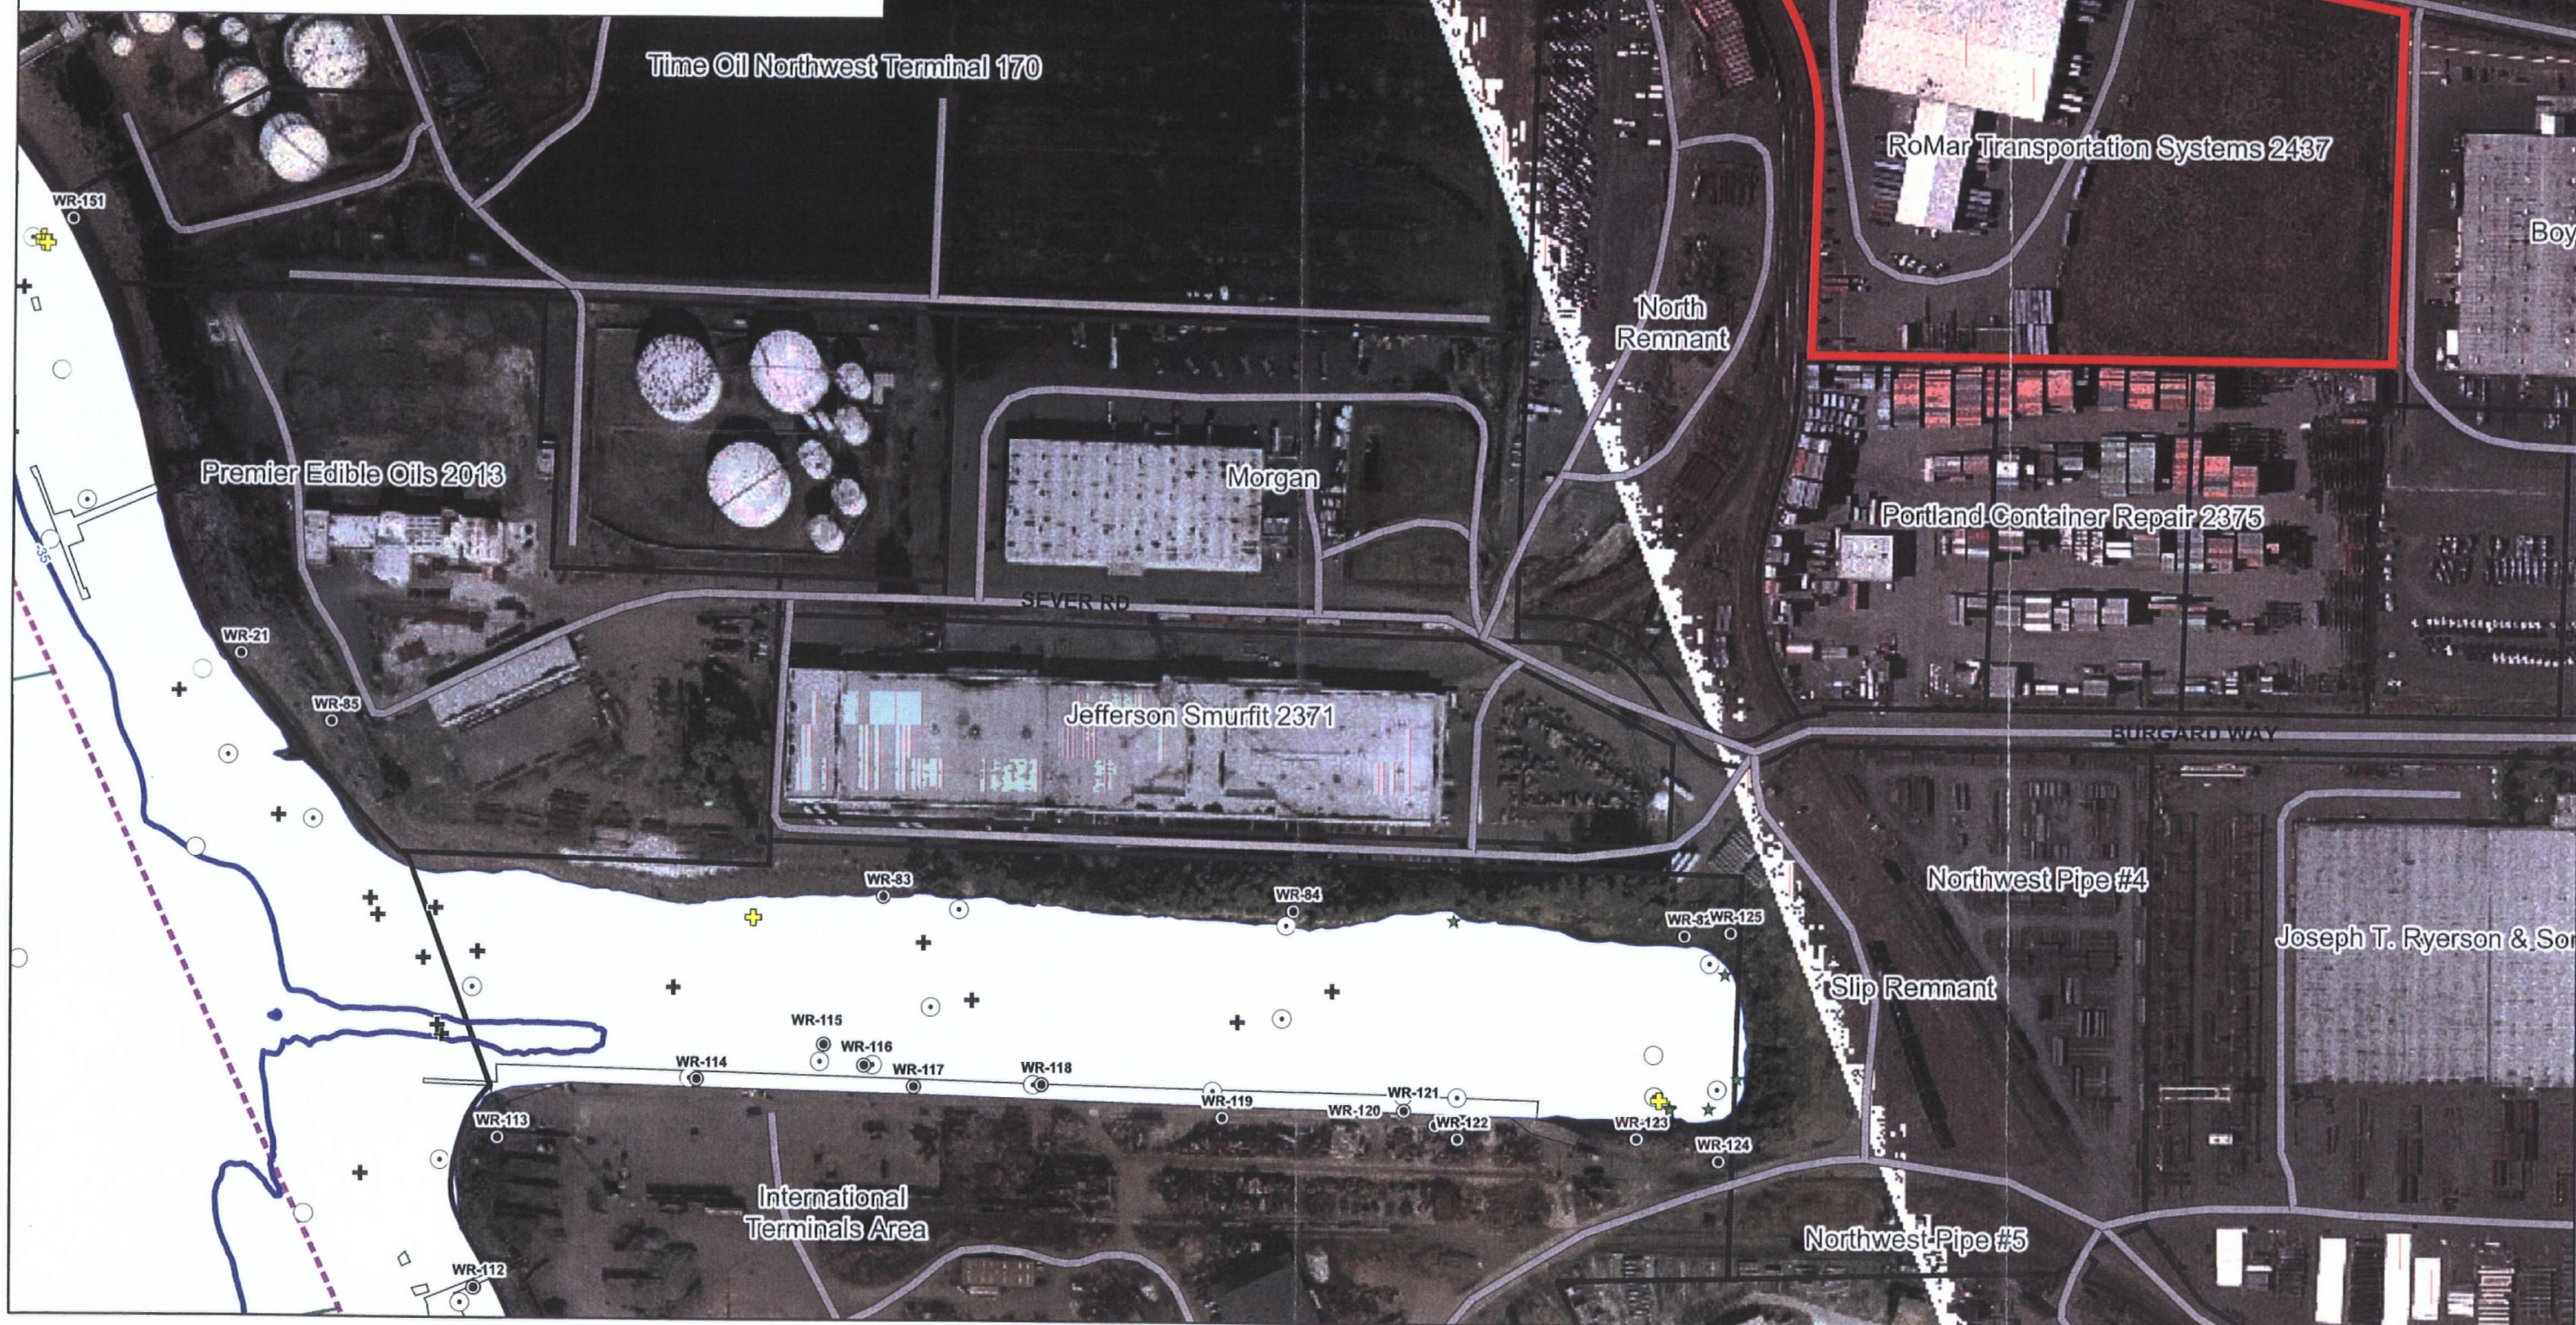
## Round 1 and Historical Samples Not Queried for Inclusion in Table 2

- Round 1 Sediment Samples
- Historical Sediment Samples

Map Document: (C:\GIS\Projects\Portland\_Harbor\LWG-Map-Project\Conceptual\_Site\_Model\Sample\_Locations\_3rd\_Group.mxd)  
 Plot Date: 05/26/2005  
 Aerial Photo Date: October 2001.  
 Base Map features from Portland Metro's RLIS.  
 Outfall information contained on this map is accurate according to available records; however, the City of Portland makes no warranty, expressed or implied, as to the completeness or accuracy of the information published (updated March 2005).
